# Manhole Inspection Summary

Manhole # S29EE1022MH

Insp Date: **12/20/06 1:14 PM**

**Location** Address: **3829 KESWICK RD**

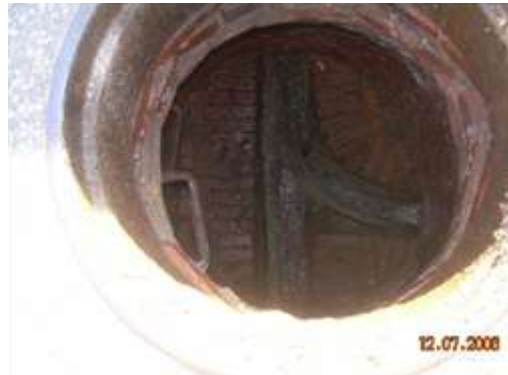
Top View

Corroded steps. Evidence of surcharge - Bench debris.

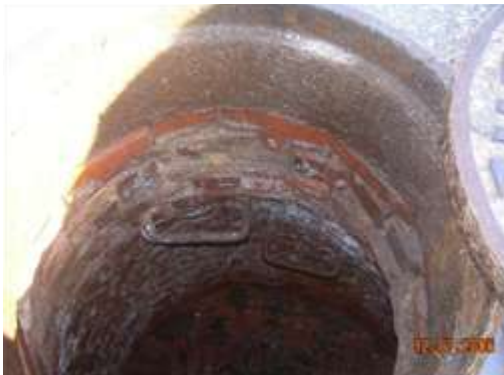
Defect

Frame leaks. Adjustment deterioration and infiltration. Corbel and Barrel infiltration.

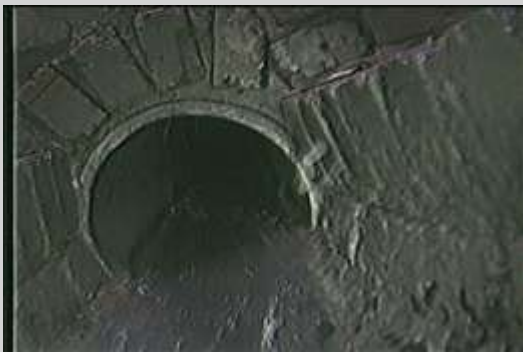
### 10 in. Circular Gravity Sewer Pipe Out @ 12 O'Clock

Infiltration: **Evidence** Pipe Seal Cond: **Unknown**

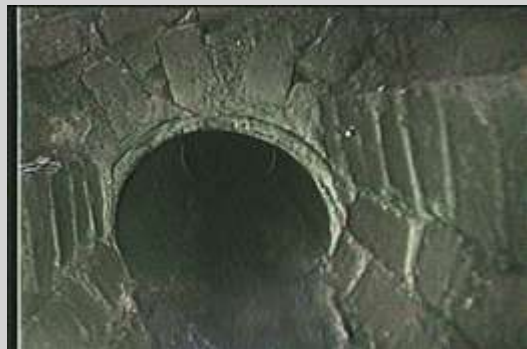
10 in. Circular Gravity Sewer

Barrel deterioration and infiltration. Channel deterioration.

Infiltration: **Evidence** Pipe Seal Cond: **Cracked**
